Department:  
Water Affairs and Forestry  
REPUBLIC OF SOUTH AFRICA

## **MZIMVUBU RIVER SPRING SURVEY**

SEPTEMBER 2008

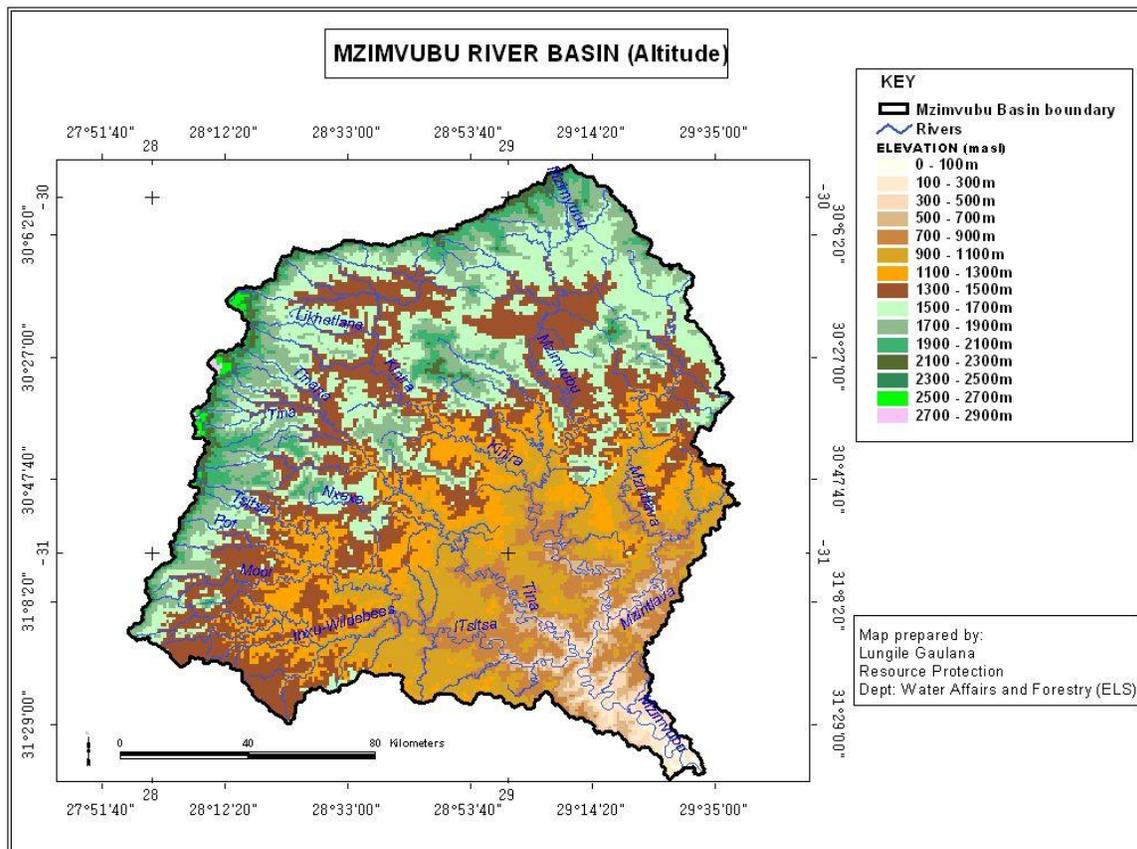
Mzimvubu River starts from an altitude of about 2 700 meters above sea level (masl) on the Drakensberg escarpment to the Indian Ocean over a distance of approximately 300 km. It drains a catchment area of approximately 19 853 sq. km ([www.ewisa.co.za](http://www.ewisa.co.za)). The mainstem has four major tributaries; the Tsitsa, Tina, Kinira and the Mzimtlava rivers, all of which their headwaters originate from the Drakensberg Mountains. After descending through the escarpment, the Mzimvubu River and its tributaries flow through deep and steep river valleys incised into the coastal belt, before discharging into the Indian Ocean at Port St Johns. The figure below shows the rough terrain of the catchment and its longitudinal profile from source to mouth.

Figure 1: Showing altitude and topography of the Mzimvubu River drainage basin (Adapted from GIS coverage, DWAF: RQS).

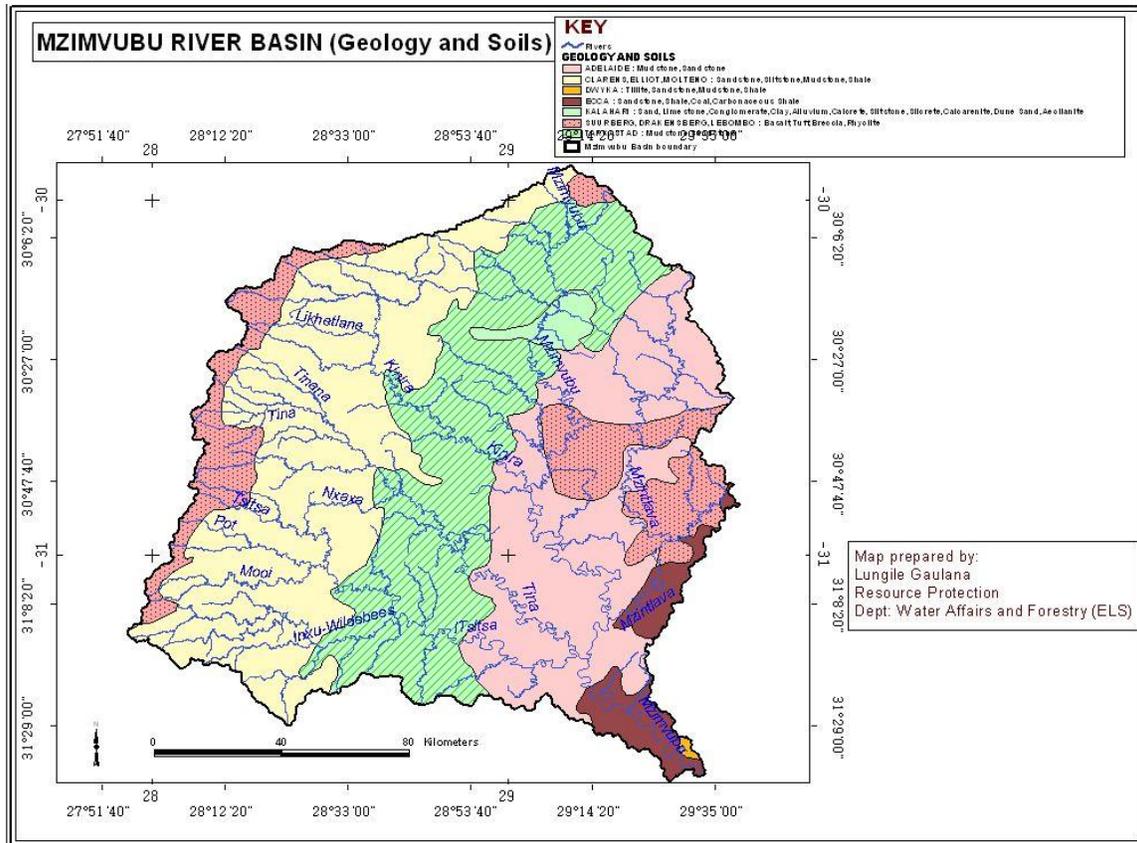
According to Moon and Dardis (1988), the abortive rifting of Pangaea resulted in the deposition of the Cape Supergroup succession of quartzitic sandstone and shales. This was followed by continental glaciations which resulted to the Dwyka Formation. Accordingly, the Karoo basin was filled with sediments of the Ecca, the Molteno, Elliot, Tarkastad, Uteinhage and Clarence Formations of the Karoo sequence. Some of these sediments are widely intruded by dolerites and sills related to Drakensberg basaltic material. The predominant rock formations in Mzimvubu River Basin are sandstone, mudstone and shale of the Karoo Sequence, with some localised intrusions of dolerite dykes and sills ([www.ewisa.co.za](http://www.ewisa.co.za)). In addition, basaltic lavas of the Drakensberg Formation occur in the upper parts of the basin and small patches of Dwyka tillite occur in the lower part of the basin. Categories of the soils in this basin are moderately deep to deep clay soils in the steep slopes of the famous Drakensberg, moderately deep clayey loams on the steep foothills of the Drakensberg and sandy loams east of the Drakensberg and as far as the Indian Ocean. The soils in the catchment are vulnerable to erosion due to their dispersive nature, duplexity and their origin from the easily weathered parent material. Less erodible material is obtained on source zones of the Drakensberg and the rejuvenated lowlands. The figure below shows the geology and soils of the Mzimvubu River catchment.

Figure 2: Geology and soils of the Mzimvubu River drainage basin (Adapted from GIS coverage, DWAF: RQS).

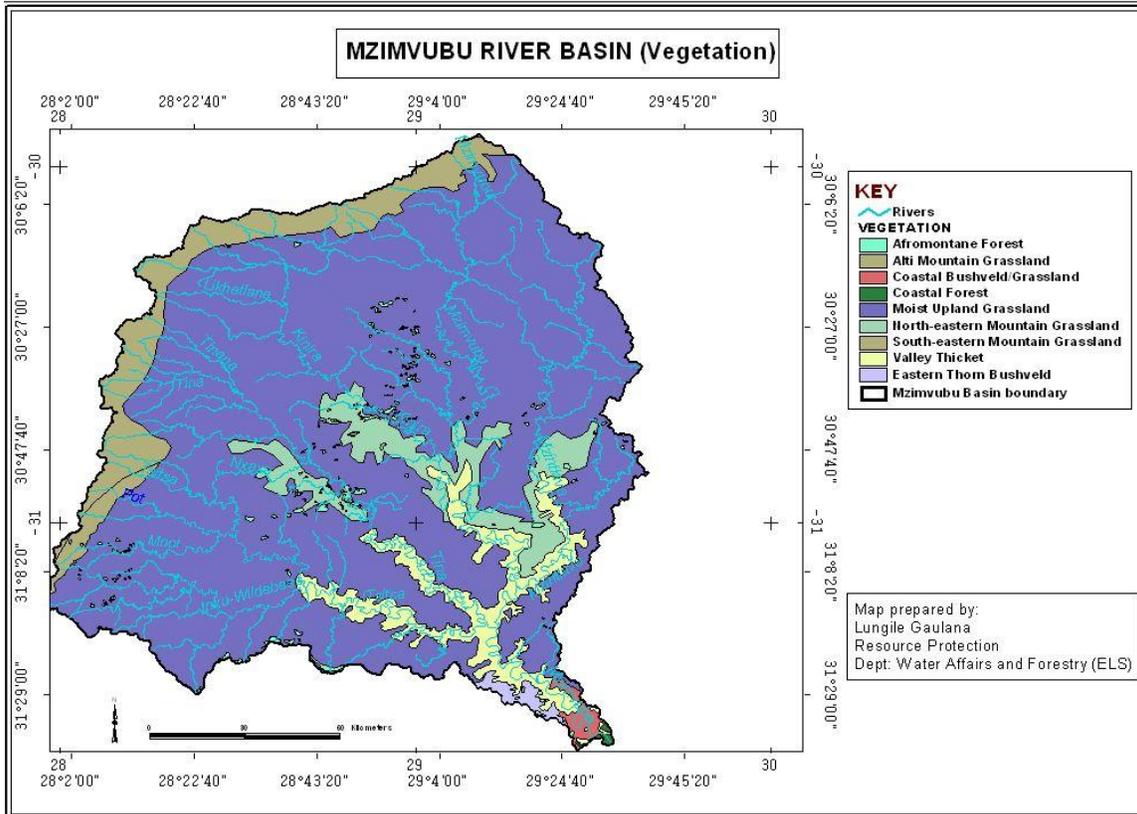
Figure 3: Vegetation of Mzimvubu River drainage basin (After Louw and Rebelo 1996)

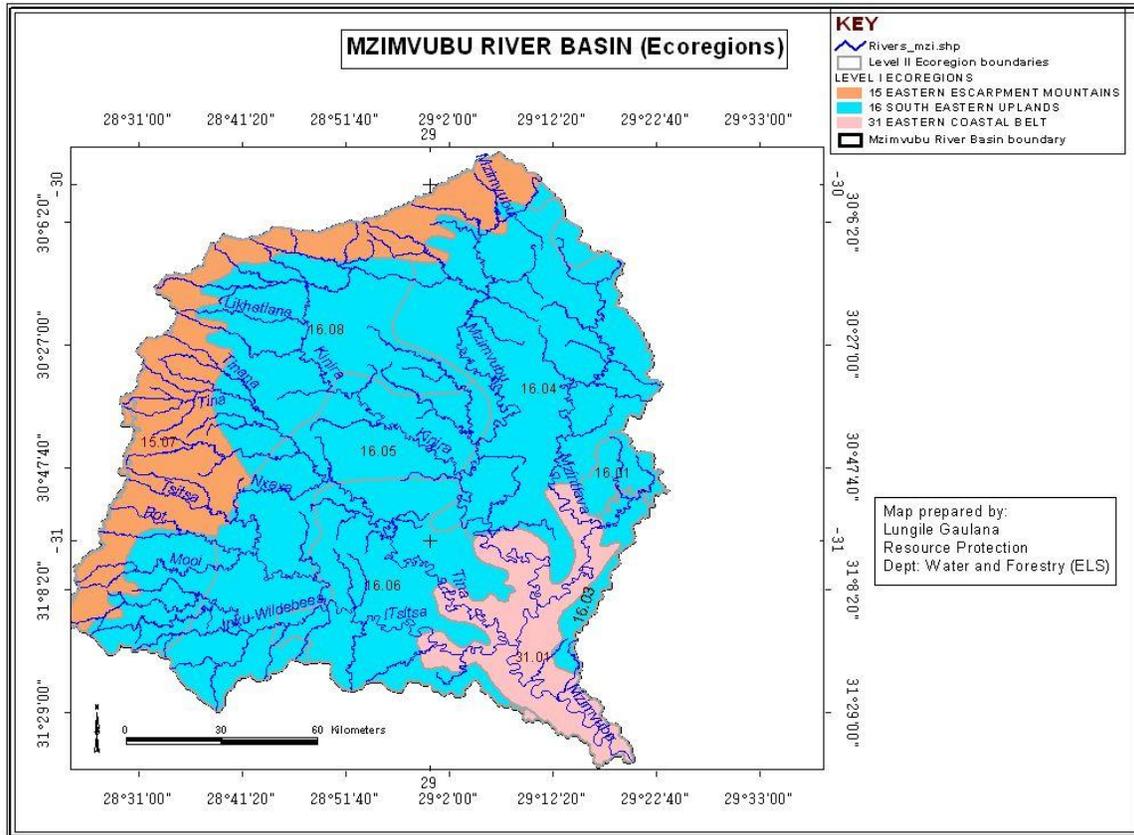
Figure 4: Showing Levels I and II Ecoregions of the Mzimvubu River drainage basin (Adapted from Kleynhans *et al*, 2005).

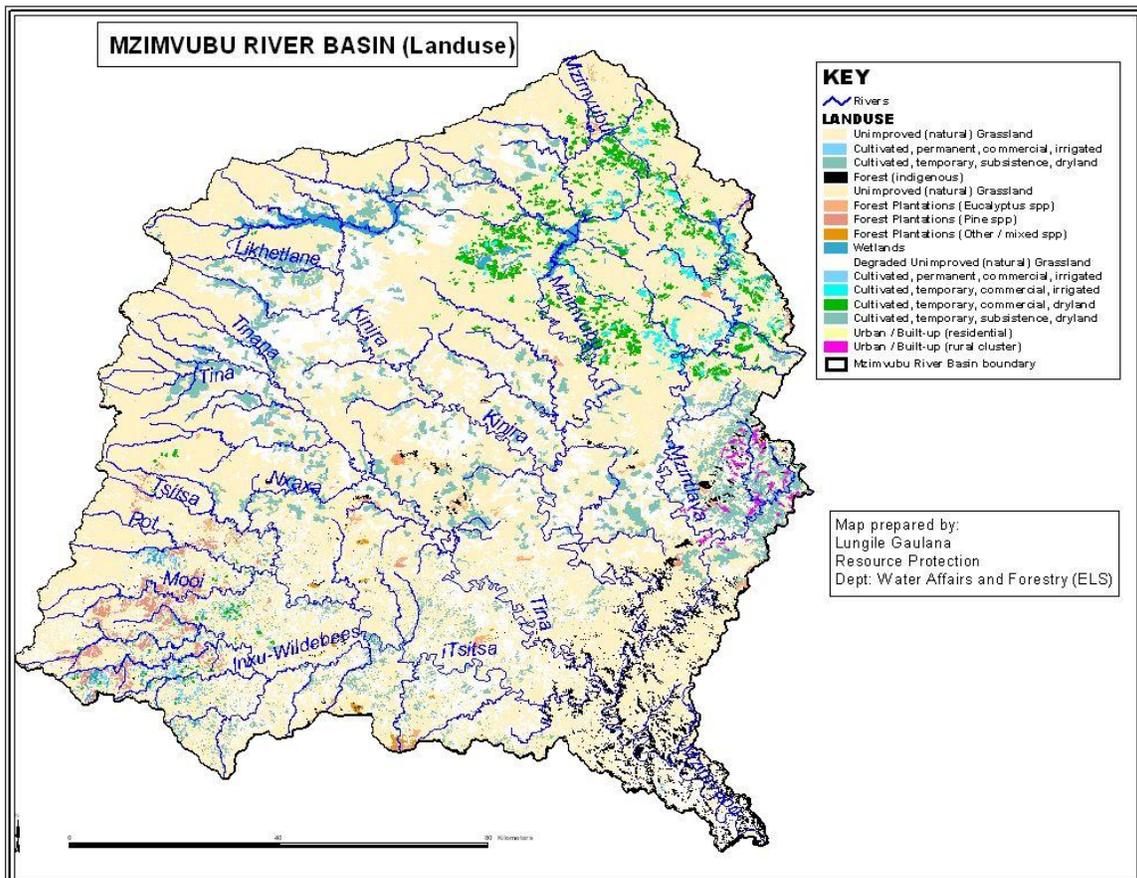
It could be noted that overgrazing, vegetation removal and alien invasion especially by Black Wattle has exacerbated erosion. Also high population densities might have had a negative effect on the natural resources of the catchment. Recent National Landuse coverage (nlc 2000) shows that pre-dominant landuse activities include subsistence and commercial agriculture, grasslands and forest plantations. The figure below shows landuse of the Mzimvubu River catchment.

Figure 5. Landuse of the Mzimvubu River Basin (After National Landuse coverage, 2000).

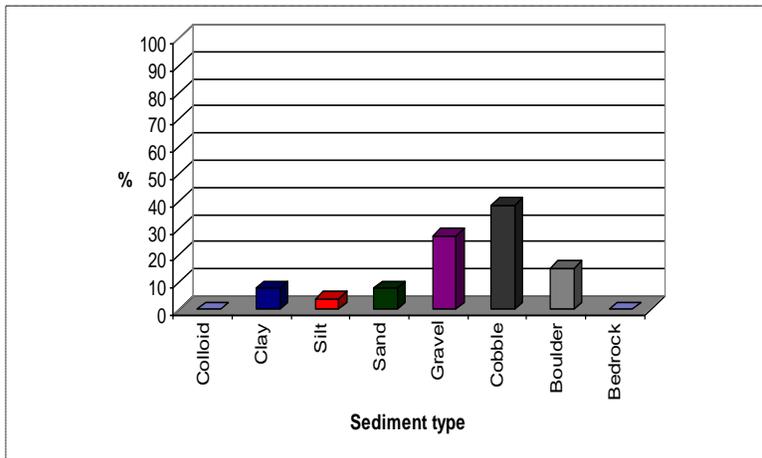
The site is located at a confined channel between two steep valleys. This means that no portion of a reach where sediment from eroded hillslope can be trapped by any means, especially if the riparian zone vegetation has been removed. It is a mixed channel where both the bedrock and alluvium are present but it is mainly dominated by bedrock. The channel is a pool-riffle. It has about 49% of morphological units where the living biota can survive. There is a localized erosion and sedimentation. Vegetation removal and subsistence farming are major disturbances. The figure below shows the percentage of sediment proportions on a site. It can be noted that there were fines deposited in the river channel.

Figure 6. Showing percentage distribution of sediment types at Tsitsa above Potrivier Pass.

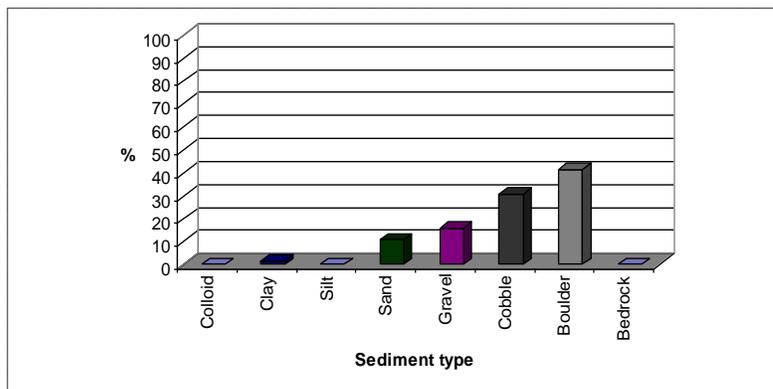
The site is also located at a reach confined on one side. It is a single thread pool-riffle system in an active meandering state. Overflow channel was observed, suggesting increased flooding combined with vegetation removal. Flat sand bed was also noticed which is an evidence of increased sedimentation. The sources of sediment at a reach scale are gullies and sheet erosion on the hillslope, accompanied by presence of alien *Acacia meansii* species. The latter also plays a significant part on river bank failure and collapse with the resultant increase in the deposition of fine material. Figure 6 below shows the variability of sediment found in the channel. Although boulders and cobbles are dominant material, sand and gravel deposits can also be noticed.

Figure 7. Showing percentage distribution of sediment types at Kinira at Mabua.

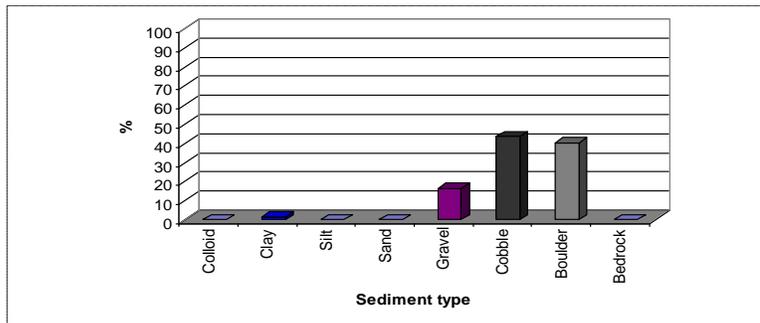
The site is also located at a reach where the floodplain is confined on one side. This means that the eroded sediment from the hillslope can either be trapped alternatively at a floodplain either at the right or the left side of the river, but never both. It is a single thread, alluvial and a pool-riffle system. This is where the river is experiencing a sinuous situation, with erosion of the river bank alternating with deposition of sediment on either left or right bank. The morphological units on a river constitute about 33%. Boulders and cobbles are dominant features of the system with gravel material and small proportion of fines deposited in between the dominant material. The figure below shows sediment proportions of a site.

Figure 8. Showing percentage distribution of sediment types of Mzimvubu at Springfontein.

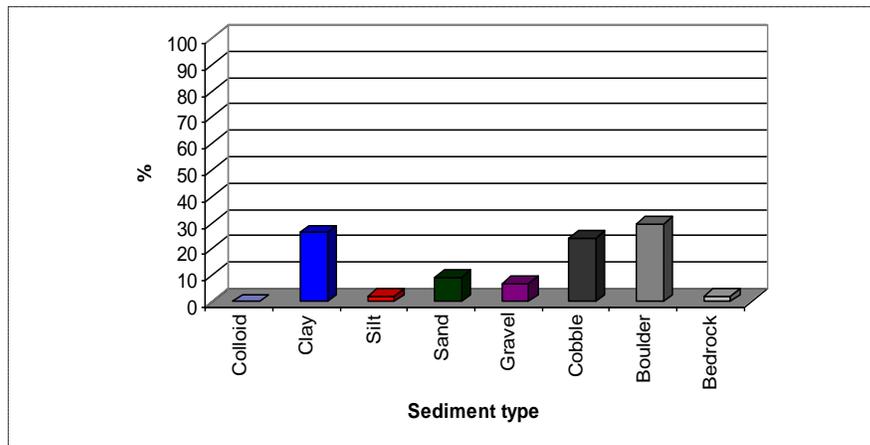
had also been removed, possible for fuelwood collection. A dam under construction above the site also contributes to sedimentation of the entire reach hence it is a seriously embedded river system. As it can be detected in the figure below, the site had a lot of fine material like gravel, sand, silt and clay in between the boulders and cobbles, with other fine material attached to the bedrock.

Figure 9. Showing percentage distribution of sediment types of Tina at Tsolobeng.

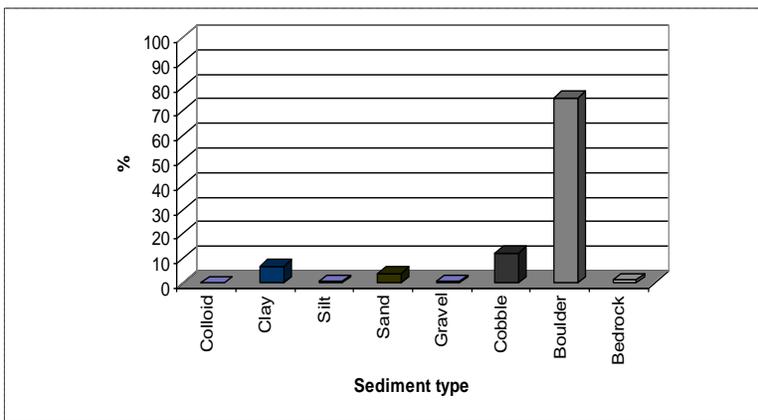
This is also a confined valley floodplain. It a pool-rapid river system with a straight and a single thread channel. The river at a site is dominated by boulders; a character of a transitional zone. It has about 79% of morphological units suggesting diversity of habitat for aquatic biota. However, active hillslope erosion, vegetation removal and overgrazing are abundant. This is a characteristic of poor pasture management which can affect adjacent water resources. Sediment sampling was carried out at a site. The figure below shows the results of sediment sampling.

Figure 10. Showing percentage distribution of sediment types of Mzintlava at Ntshakeni.

From this it can be examined that the site is invaded by fine material like sand, silt and clay particles. When running the GAI model, the site can be classified as in a C class on its Present Geomorphological State.

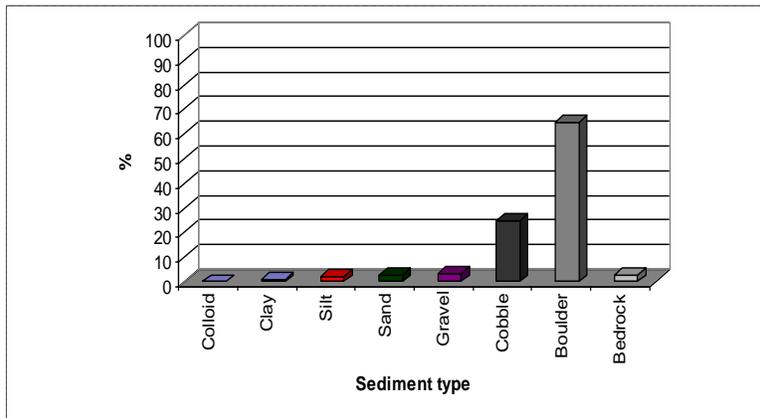
The site is at a confined valley floodplain. It is a multi-thread, mixed, pool-riffle system dominated by boulders. Erosion at catchment scale very minimal and there is less vegetation removal. About 83% of morphological units were present. As it can be illustrated in the figure below, very little fine material is found in the river at that site.

Figure 11. Showing percentage distribution of sediment types of Tina River at N2.

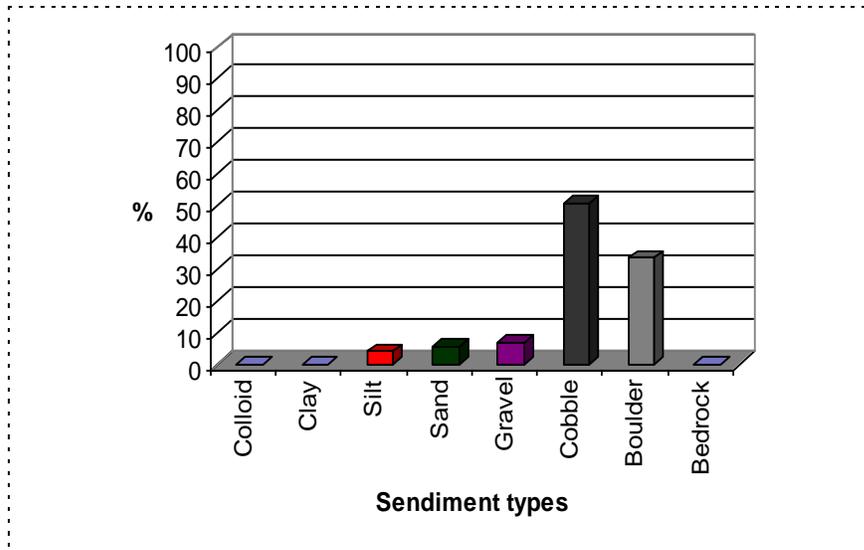
The site is also at a confined valley floodplain. It is a single thread, sinuous, pool-riffle and a mixed channel although it is composed of the cobbles as a dominant sediment type. Active erosion at a reach scale could be noticed. Deep gullies were present throughout the adjacent hillslopes of the river reach. Vegetation removal and extensive livestock grazing was also evident. Weirs and causeways were also present. The figure below show the proportion of sediment types on the river at a site. It can be noticed that the cobbles are dominant features though the boulders are also evident. The silts, sands and gravel deposits are probably from sediment sources like gullies and the overgrazed and moderately eroded neighboring hillslope.

Figure 12. Showing percentage distribution of sediment types of Tsitsa at Laleni.

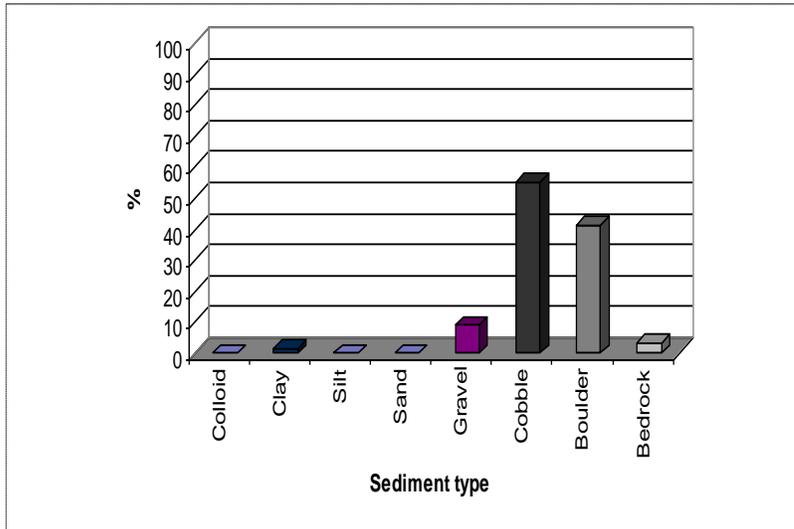
The figure below shows the results of sediment types sampled at a site. It can be noticed that the sediment sampled is dominated mainly by cobbles though the boulders are also major features observed. Some gravel deposits also exist that are probably from adjacent hillslopes and upstream of the site as well as from the river bank.

Figure 13. Showing percentage distribution of sediment types of Mzintlava at kuPoyi.

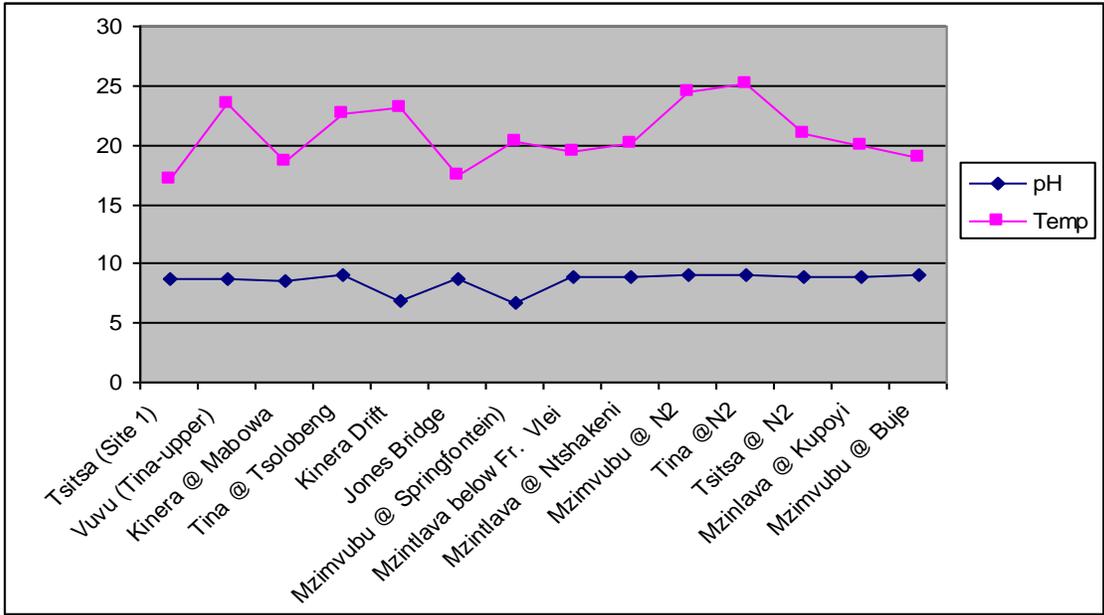
Figure14 Comparing temperature and pH.

Date	DO(ppm)	pH	Conductivity(mS)	Temp
Tsitsa above pot river pass)	29/09/2008	0.03	8.68	0.07	17.1
Vuvu (Tina-upper) reference site		0.05	8.79	0.12	23.5
Kinia @ Mabua	30/09/2008	0.04	8.53	0.08	18.6
Tina @ Tsolobeng		0.05	9.04	0.11	22.6
Kinira Drift		0.08	8.93	0.18	23.1
Jones Bridge	01/10/2008	0.02	8.64	0.05	17.5
Mzimvubu @ Springfontein)		0.04	8.3	0.08	20.2
Mzintlava below Fr. Vlei		0.04	8.91	0.07	19.4
Mzintlava @ Ntshakeni	02/01/2008	0.1	8.8	0.21	20.1
Mzimvubu @ N2		0.1	8.97	0.2	24.4
Tina @N2		0.05	8.99	0.11	25.1
Tsitsa @ N2		0.06	8.87	0.12	20.9
Mzintlava @ KuPoyi	03/10/2008	0.09	8.93	0.19	19.9
Mzimvubu @ Buje		0.19	9.07	0.09	19

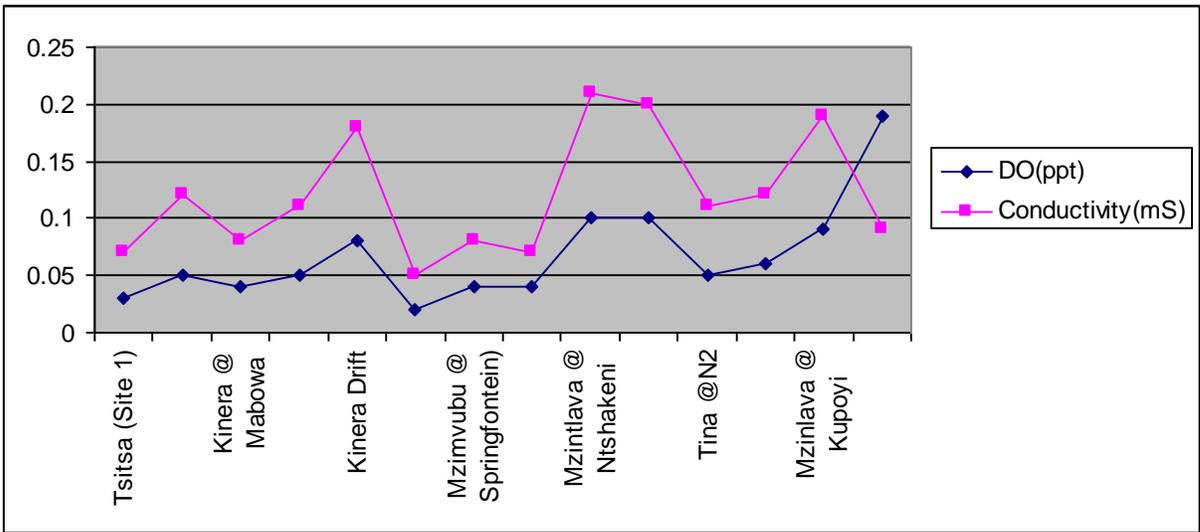
Figure? Comparing dissolved oxygen (DO) and conductivity (note the positive correlation except at Mzimvubu at KuPoyi).

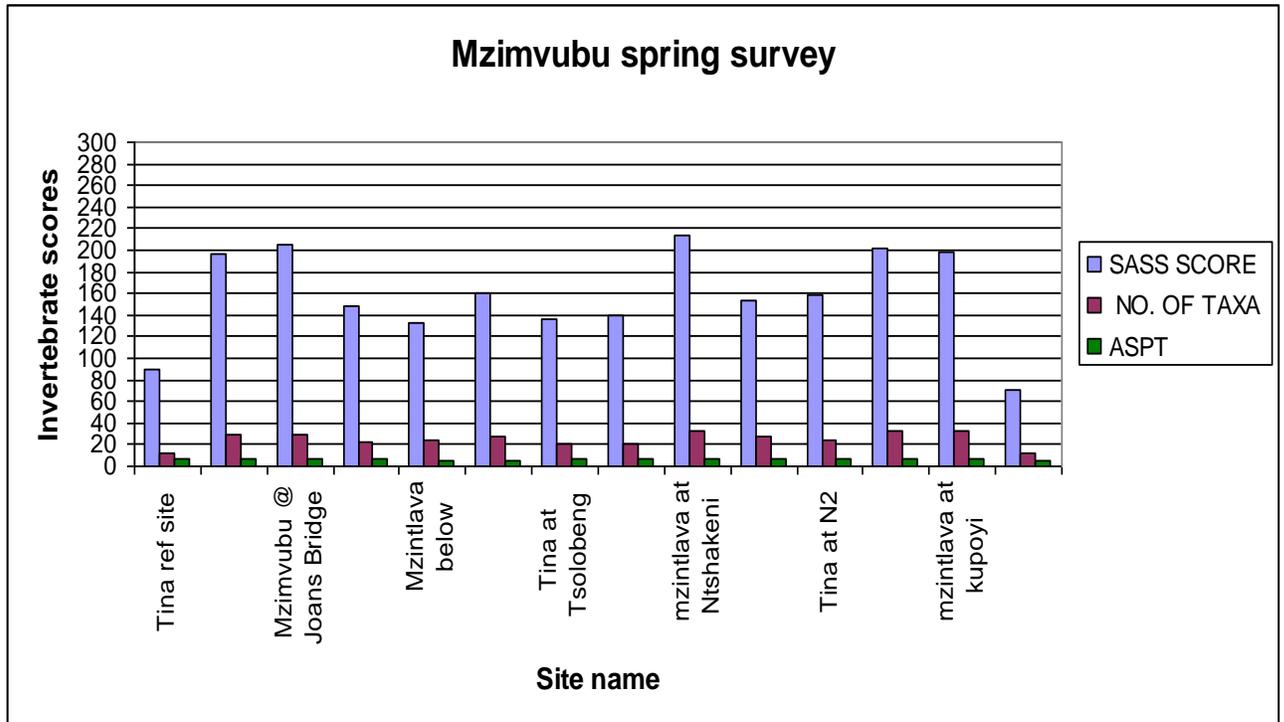
The results of invertebrate assessment during the survey is shown in the figure below.

Figure 15. Results of invertebrate sampling in the Mzimvubu River Basin.

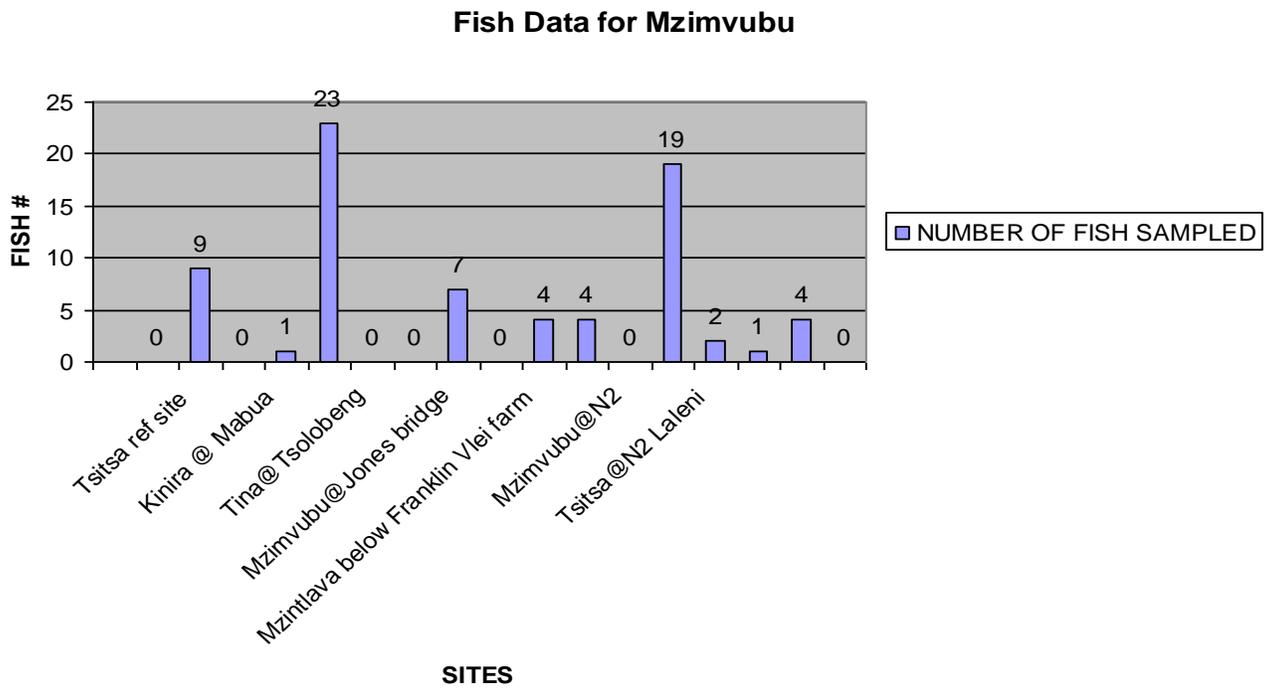
Figure 16: Fish results.

SITE	SPECIES	NUMBER OF FISH SAMPLED
Haverspruit	No sampling done	0
Tsitsa ref site	<i>Oncorhynchus mykiss</i>	9
Vuvu (Tina upper)	No fish caught	0
Kinira @ Mabua	<i>Oncorhynchus mykiss</i>	1
		23
<u>Tina @Tsolobeng</u>	No fish caught	0
Kinira drift	<i>No fish caught</i>	0

<u>Mzimvubu @ Jones bridge</u>	<i>Oncorhynchus mykiss</i>	7
<u>Mzimvubu @ Springfontein farm</u>	No fish caught	0
Mzintlava below Franklin Vlei farm	<i>Micropterus salmoides</i>	4
<u>Mzintlava @ Ntshakeni</u>	<i>Cyprinus carpio</i>	4
<u>Mzimvubu@N2</u>	No fish caught	0
<u>Tina@N2</u>	<i>Barbus anoplus</i>	19
<u>Tsitsa@N2 Lalen</u>	<i>Anguilla mossambica</i>	2
<u>Mzintlava KuPoyi</u>	<i>Barbus anoplus</i>	1
	<i>Cyprinus carpio</i>	4
Buje	No fish caught	0
